BAGHDAD RAILWAY STATION
REHABILITATION
BAGHDAD, IRAQ

SIGIR PA-06-057
JULY 25, 2006

SUBJECT: Report on Project Assessment of the Baghdad Railway Station
Rehabilitation, Baghdad, Iraq (Report Number SIGIR-PA-06-057)

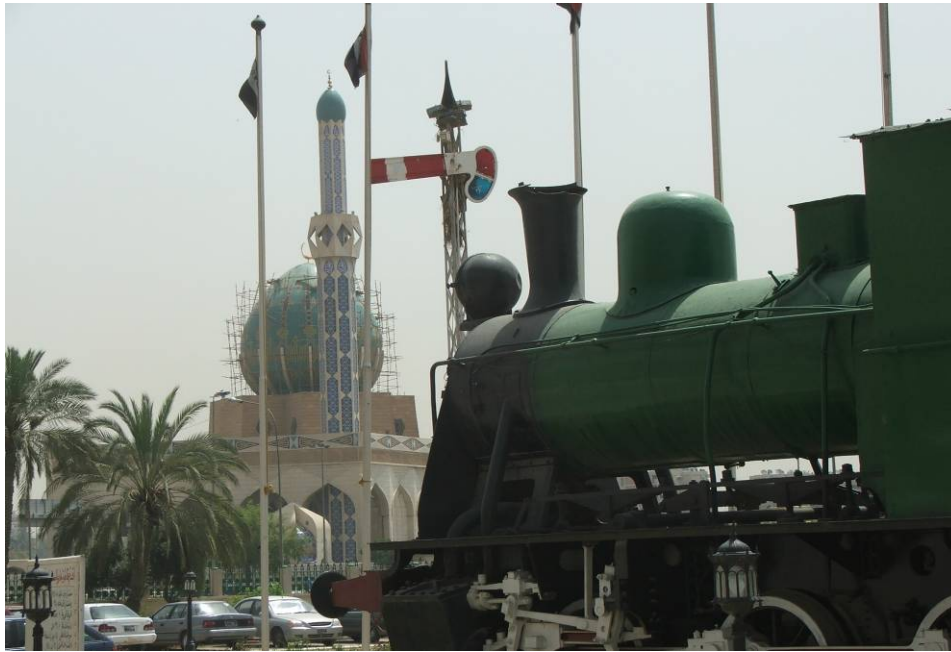
Site Photo 2. View of original railway car displayed in front of Baghdad Railway Station

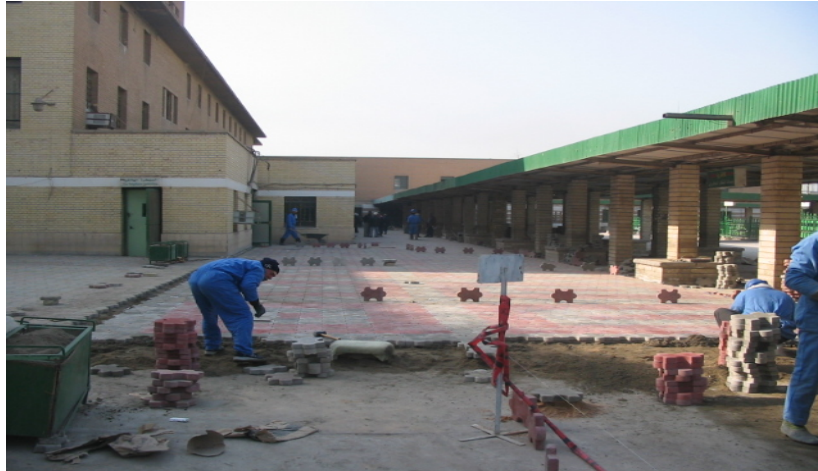
Site Photo 5. Work in progress on passenger waiting platform
(Photo courtesy of the USACE)

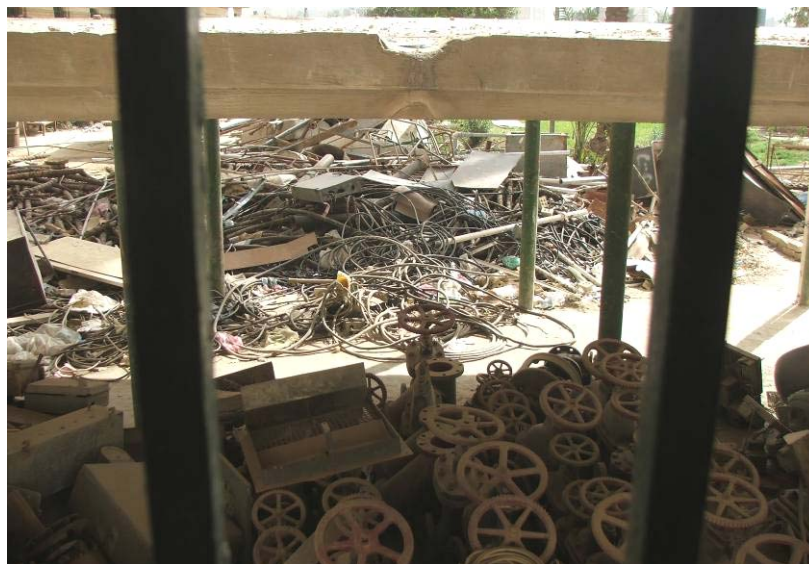
The demolition and clean-up portion of the contract was de-scoped. During our site visit, we identified old parts and miscellaneous equipment that were removed from the basement (e.g., valves and electrical cable) and stored on site adjacent to the east side garden area. According to the USACE DRE, the IRR wants to retain the equipment to resell it for revenue at a future auction. Site Photo 9 shows the excess material.

Site Photo 9. View of old parts located on site

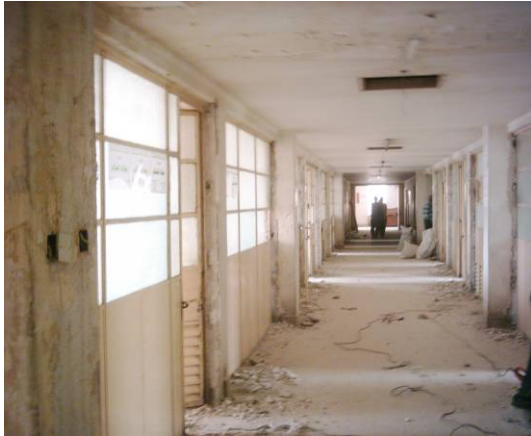
Site Photo 11. View of existing interior partitions
(Photo courtesy of USACE)

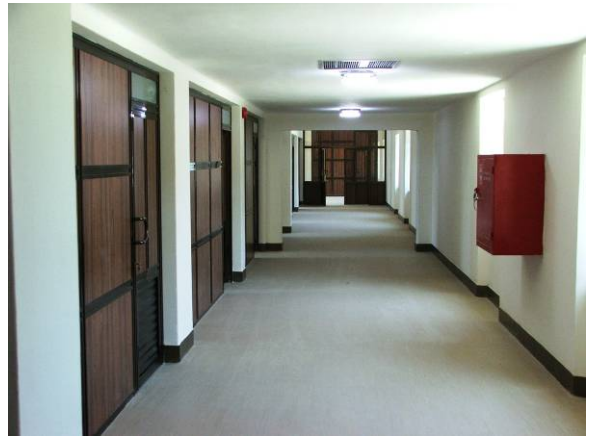
interior partitions with aluminum partitions consisting of MDF and reinforced glass. The observed partitions appeared to meet the standards of the design.

Site Photo 12. View of new interior partitions

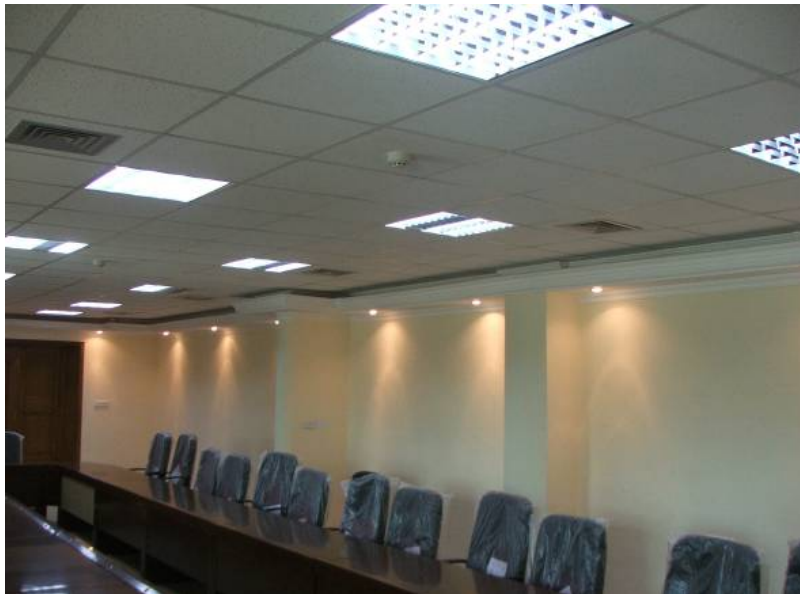
Site Photo 13. Conference room with suspended acoustical ceiling

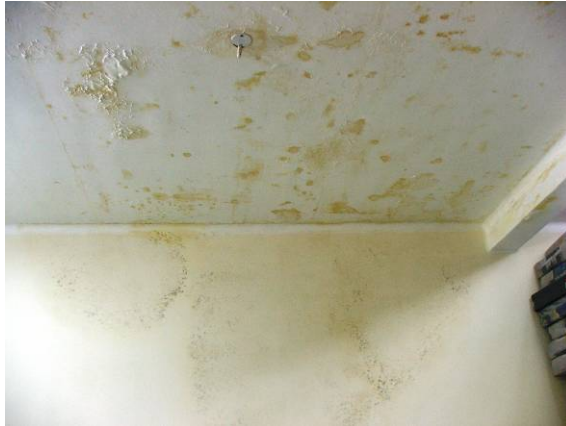
During the first site visit, we observed water damage (blistered and peeling paint as seen in Site Photo 14) on the concrete ceiling in one of the ground floor offices. The DRE informed the assessment team that the water damage occurred because the floor

Site Photo 14. Water damage to ceiling caused by rainwater leakage from above

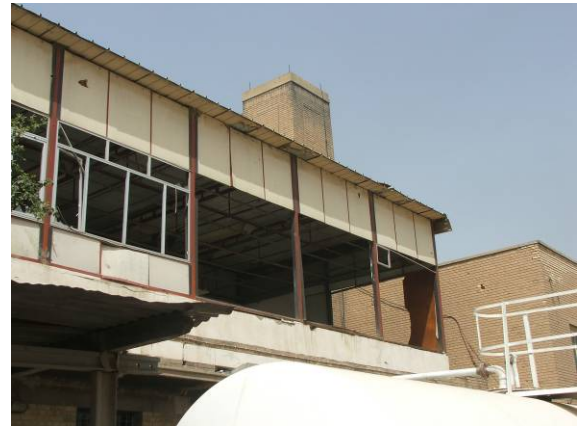
above contained a restaurant (Site Photo 15) that had been looted prior to the project and was exposed to the elements. Thus, rainwater trapped in the old restaurant leaked into the room below. The renovation scope of this project did not include the restaurant.

Site Photo 15. Old restaurant exposed to weather resulting in leaks below

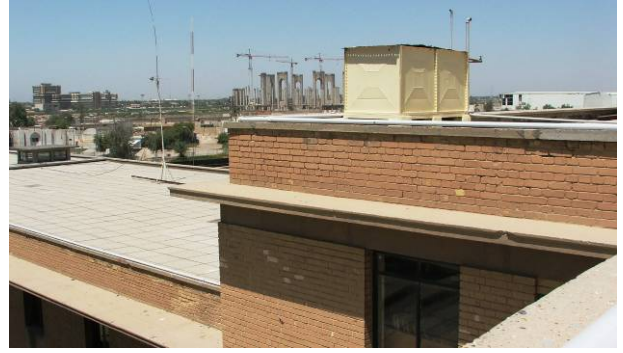
Site Photo 17. Roof top galvanized water tank

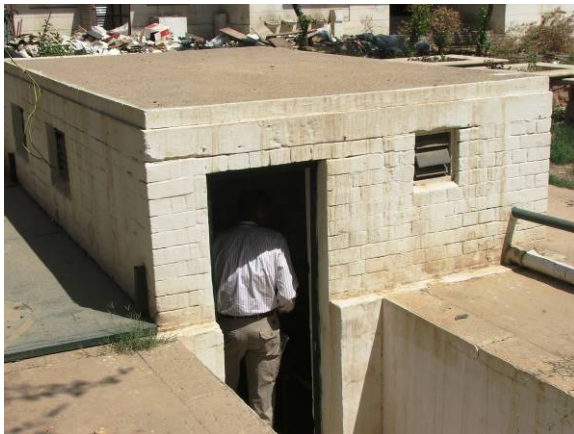
Site Photo 19. One of the two sewage pump houses

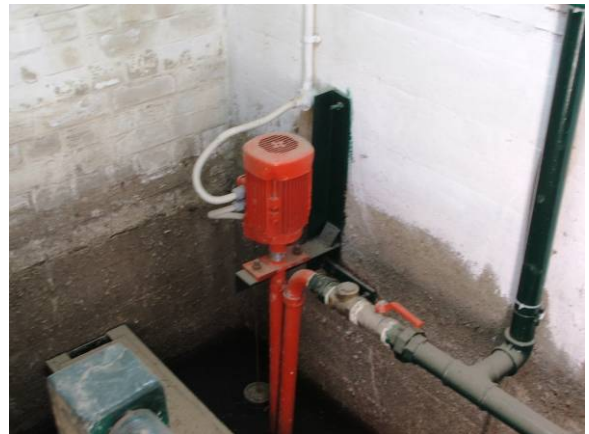
The IRR has issues with the pumps as noted in a letter to the contractor dated 14 June 2006, indicating the pumps (item 2) need to be heavy duty. The contractor responded that the pumps comply with the submittal requirements that had been approved by the IRR.

Site Photo 20. One of two electrical sewage pumps in the pump house

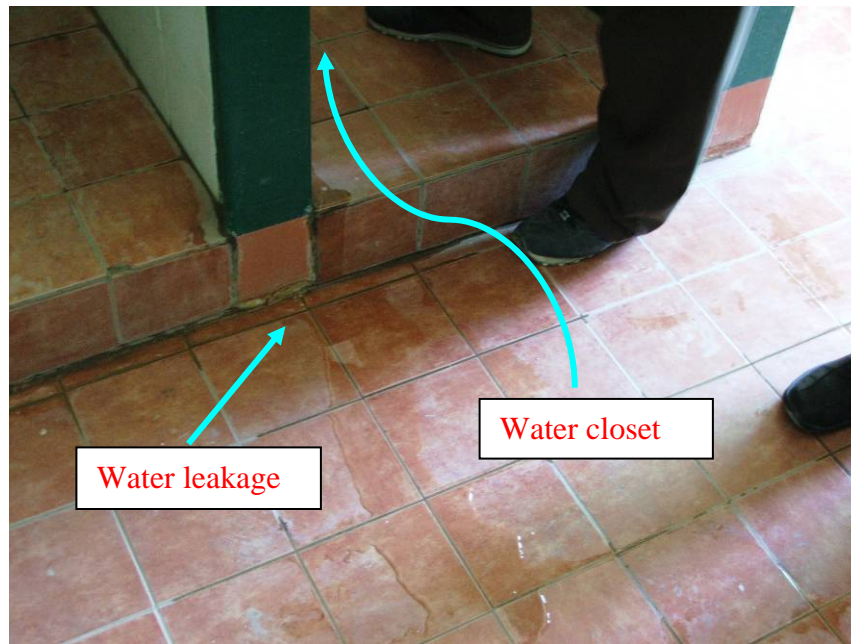
Bathrooms included a floor drain near the middle of the floor. On some of the bathrooms, water faucets were adjacent to the toilets to facilitate cleaning. The bathrooms were renovated according to the design. However, based on information provided to us by the USACE DRE, in three of the bathrooms, because of space constraints, the floor's slope was not enough to adequately drain the water to the

floor drain and to the toilets within the water closets. Thus, water continually ponds and has eventually permeated along the interface between the bathroom floor and the step into the water closet as shown in Site Photo 21.

Site Photo 21. Standing water in one of the station's bathrooms

At the time of the assessment, the USACE DRE and contractor were working to develop a solution that would eliminate the standing water while satisfying the requirements of the IRR.

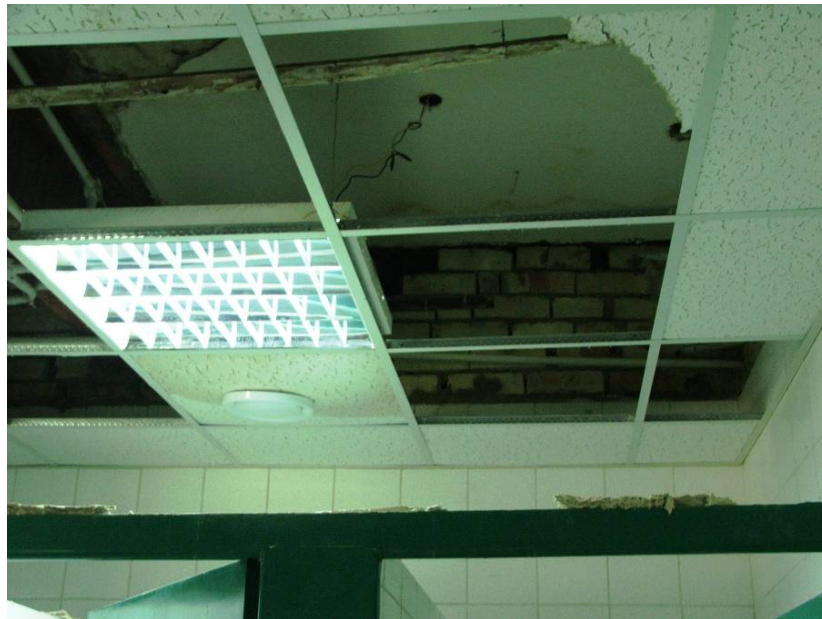
As a result, water has leaked into the bathroom on the floor below, causing damage to the suspended acoustical ceiling. Site Photo 22 shows some of the damage that occurred in the bathroom below.

Site Photo 22. Water damage to the suspended ceiling

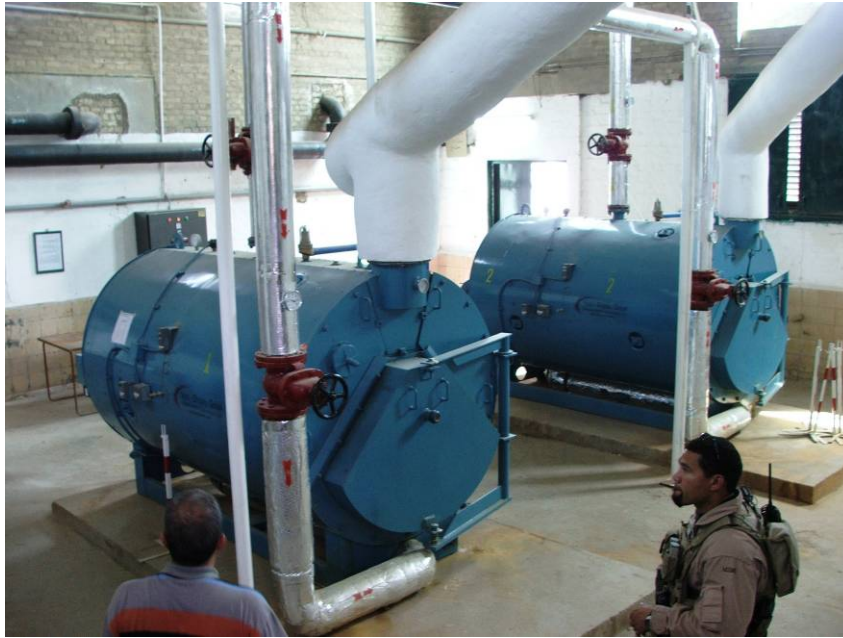
In addition to air conditioning, the design required the installation of two packaged hot water boilers for heating in the winter time, each with a heating capacity of 1,000 kilowatts (kW). The BOQ listed a requirement for two, hot water boilers (950 – 1000 KW) capacity, western source, diesel fuel with accessories for operating with a water softener. The contractor installed two York-Shipley boilers, each with a listed capacity (based on the York-Shipley submittal) of 981 KW, as shown in Site Photo 24.

Site Photo 24. York Shipley hot water boilers

The assessment team verified their installation as well as the required water softener, and hot water circulation pumps. We did not notice any apparent defects with the boilers or the supporting equipment, including evidence of prior leaks. The insulation on the hot water pipes also appeared adequate, with no noticeable defects.

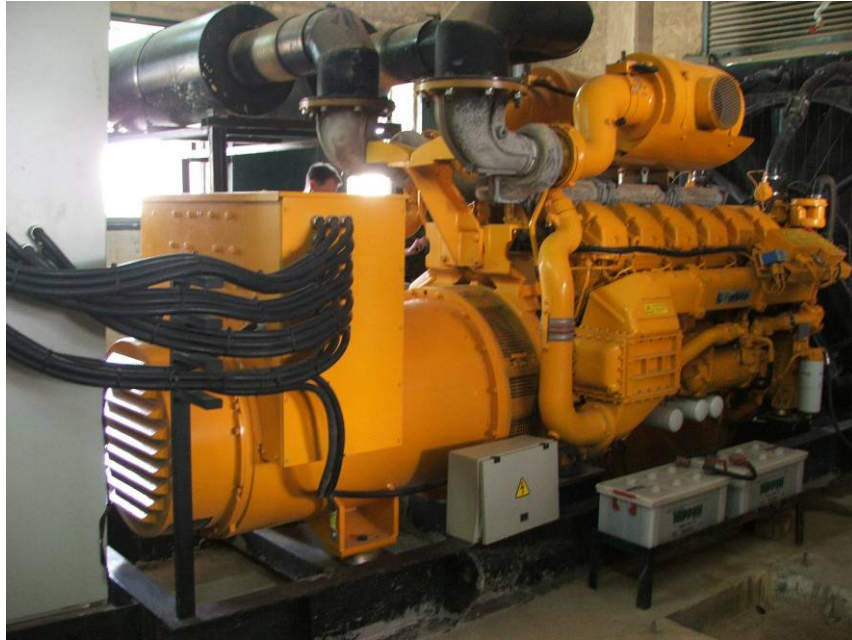
The design required two 1,250 KVA generators. The BOQ lists a requirement for one generator, although the DRE indicated an identical second generator was government furnished by PCO. While on site, the assessment team verified the contractor installed two 1,250 KVA Perkins generators in the powerhouse location shown on the design. Site Photo 25 shows one of the two Perkins generators.

Site Photo 25. One of two Perkins 1,250 KVA generators

We did not observe the generators operating on either of the two site visits when we toured the powerhouse. However, power from the city grid is not reliable, and the generators have operated on a routine basis since their installation. The final punch list does not list deficiencies associated with the generators themselves, although there remain some issues associated with how they are operated.

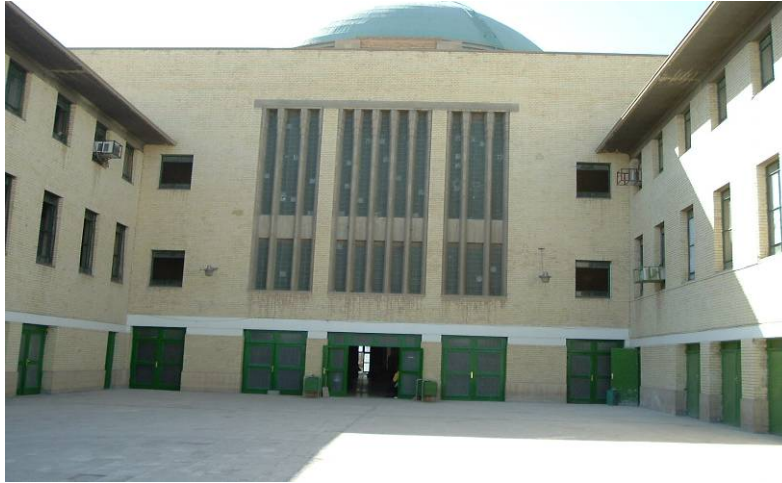
Site Photo 28. Rear view of railway station – site of future canopy

There is a pending modification to add the following: a Reverse Osmosis water purification unit for the chillers; install a canopy in the rear of the station (Site Photo 28); install drainage piping for the passenger platform area; demolish two damaged cafeterias; and install an incoming 11 kV feeder from the Iraq National Grid to serve as a redundant feeder. In addition, as mentioned earlier, discussions are still ongoing between the Resident Office, IRMO and GRD/PCO officials regarding the new sewage station pumps, maintenance of the gardens, and other items that the IRR
